Manhole Inspection Summary

Manhole # S37A__023MH

Location Address: **403 e centre st**

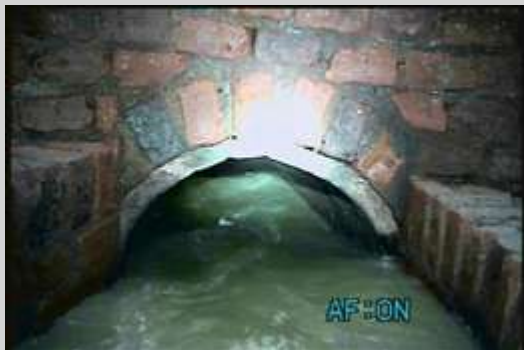
12 O'Clock Outflow

15 in. Circular Gravity Sewer
Pipe Out @ 12 O'Clock

Invert Depth: **10.88** (ft.) Flow Characteristics: **Fast**

Deposits: ☒ None ☐ Mud ☐ Sludge ☐ Debris ☐ Grease

Infiltration: **None** Pipe Seal Cond: **Unknown**

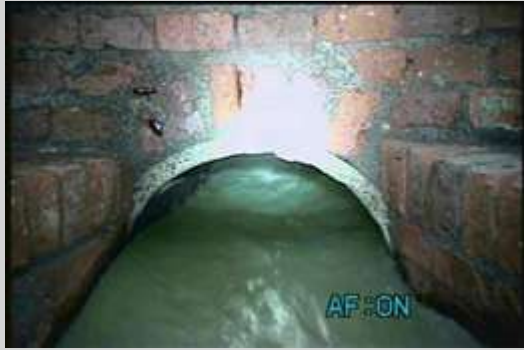
7 O'Clock Inflow

15 in. Circular Gravity Sewer
Pipe In @ 7 O'Clock

Infiltration: **None** Pipe Seal Cond: **Unknown**
